*****SAFETY ALERT*****

Compressed Gas Cylinder Warning

June 2005

IMMEDIATE INSPECTION and CORRECTIVE ACTION REQUIRED

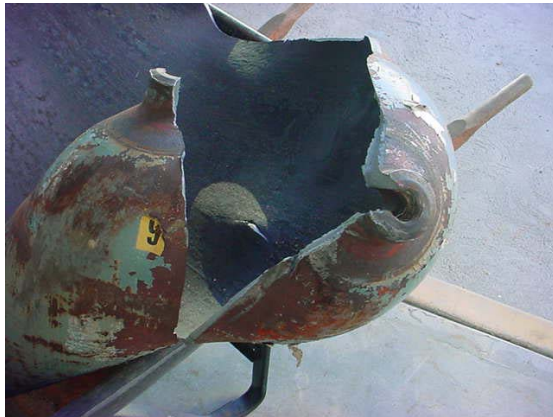
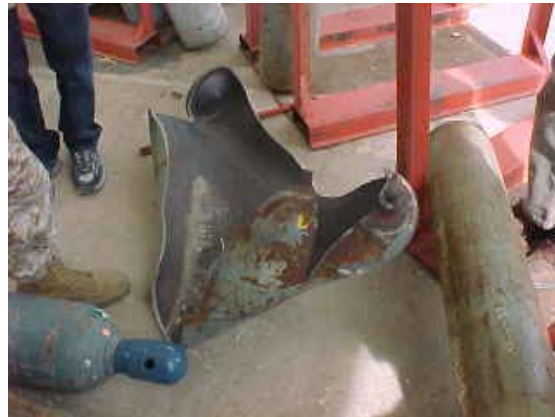
A catastrophic compressed gas cylinder failure occurred in an unattended storage lot.

Debris from the blast was found as far away as 250'. Other 150 lb cylinders were ejected up to 60' with one cylinder launching itself out to the 250' distance. This cylinder would have traveled farther had it not ricocheted off of a conex box and lodged up against a commercial grade chain link fence.

The cause of the failure was determined to be an improper pressure relief device.

Immediately check all compressed gas cylinders within your areas.

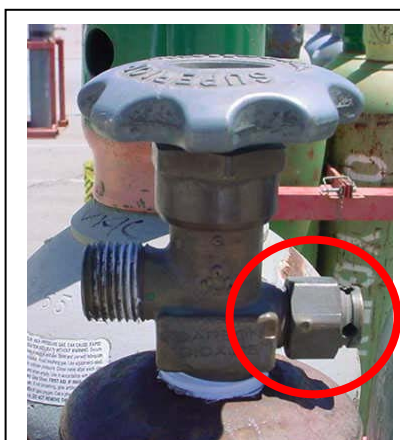
The pressure relief device is located directly opposite of the threaded discharge port.

Proper CG-1 Pressure
Relief Device

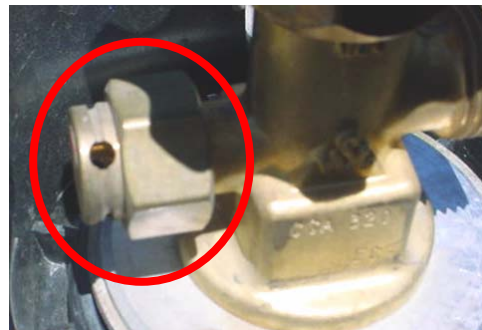
Proper CG-1 pressure relief device.

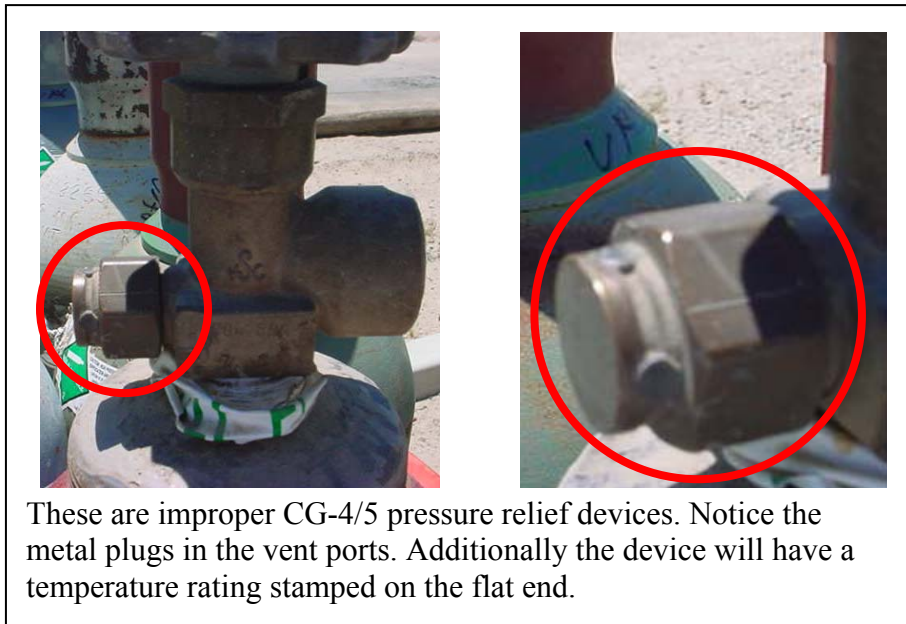
These examples are "not" proper relief devices

The holes in these devices are stopped up with a fusible metal.
